# CAPITAL RESERVE STUDY

## CATEGORY 2: UPDATE WITH ON-SITE REVIEW

### SILVER RIDGE PARK EAST HOMEOWNERS ASSOCIATION 979 EDGEBROOK DRIVE NORTH, TOMS RIVER, NEW JERSEY, 08755

Fiscal Year: 2025  
Fiscal Year Date Span: April 1, 2025- March 31, 2026  
Care of: Self-Managed  
979 Edgebrook Drive North, Toms River, NJ 08755  
Job Number 4336.0001  
Prepared: September 2024  
Revised: July 2026

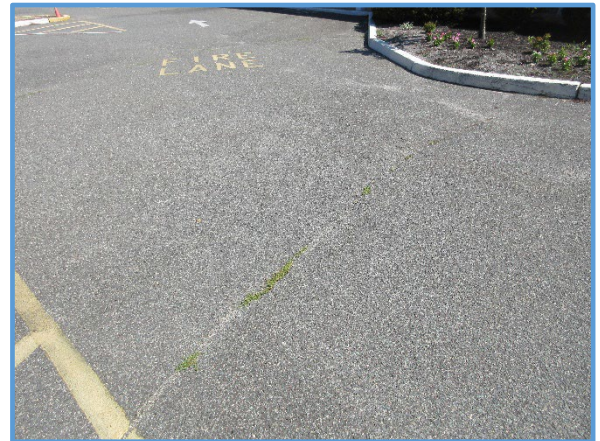
Asphalt Roadways

The parking areas within the community are constructed of bituminous concrete paving. Bituminous paving has a typical useful life of twenty (20) years, after which it is expected to receive a new two (2") inch thick asphalt wearing surface.

The parking area was observed to be in average to below-average condition, exhibiting areas of exposed aggregate, cracking and incidental damages present.

Prior to the installation of a new wearing course, milling, crack repair, and reconstruction of base course failure are expected to occur. The costs to perform these additional operations are included in the unit cost provided within the schedule.

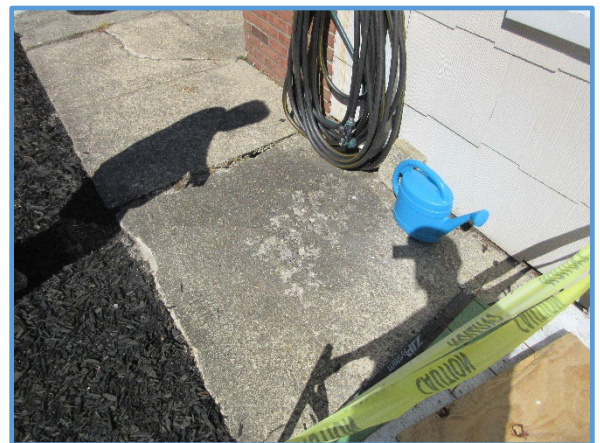
Concrete Sidewalk

The sidewalks at the community are constructed of Portland Cement concrete, which has a thirty (30) year typical useful life. The sidewalks were observed to be in average to below-average condition experiencing areas of spalling, exposed aggregate, and cracking. Any areas of sidewalk posing possible trip or *safety* hazards should be replaced immediately to eliminate the hazard.

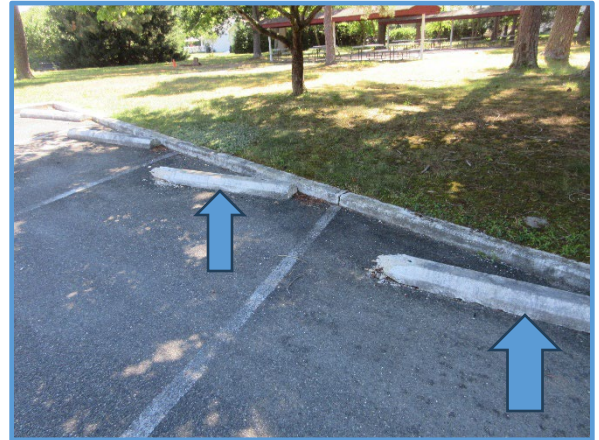
*Timber Curbing*

Timber curbing is located in the western end of the parking lot and has a typical useful life of fifteen (15) years. The timber curbing was observed to be in average condition for its age, with areas of deterioration and splitting wood present.

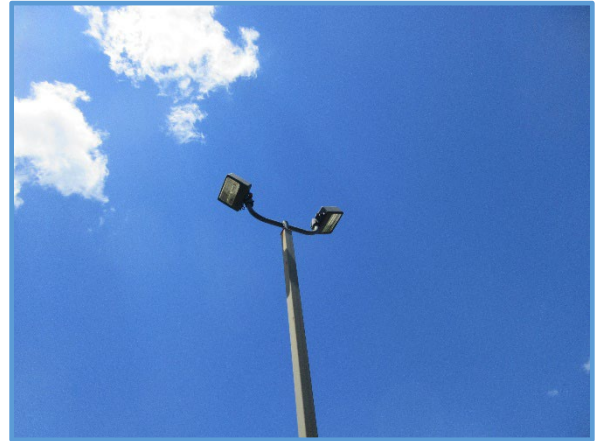
*Light Fixture*

The exterior areas of the community are illuminated by various types of light fixtures, which possess a typical useful life of twenty-five (25) years. The light fixtures were observed to be in average to below-average condition with corrosion, fading, and finish loss present.

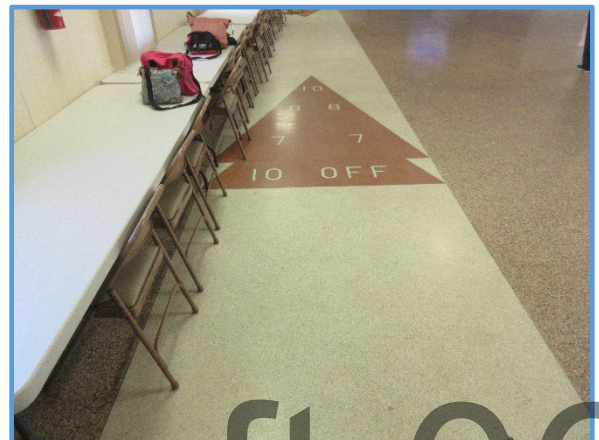
*Shuffleboard Court*

A shuffleboard court exists inside the clubhouse. The court has a typical useful life of thirty (30) years and was observed to be in average condition with minor scuffs present.

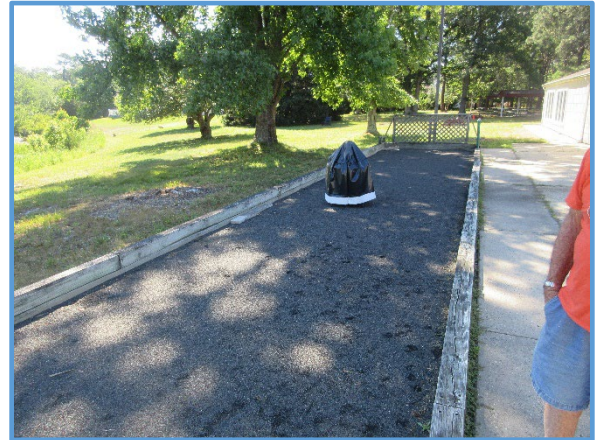
*Bocce Court*

There are two (2) bocce courts located within the recreational area. The courts are constructed of a gravel playing surface. Bordering the court is a timber edging which has a typical useful life of fifteen (15) years. The bocce court components were observed to be in average condition for their age, with loose gravel present.

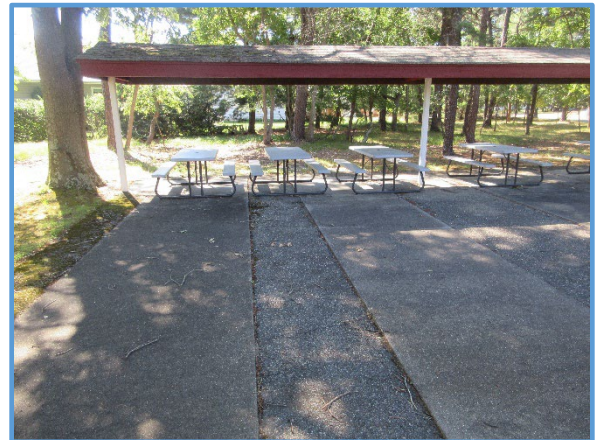
*Shade Structure*

The picnic area is provided with shade structures, picnic tables and benches. The shade structures are constructed of 3-tab roofing shingles atop of a wood shade structure with metal columns. The shade structures possess a fifteen (15) year typical useful life and were observed to be in below-average condition. The picnic tables and the wood benches have a typical useful life of fifteen (15) years and were observed to be in average condition. The concrete and metal benches have a twenty (20) year useful life and were also observed to be in average condition.

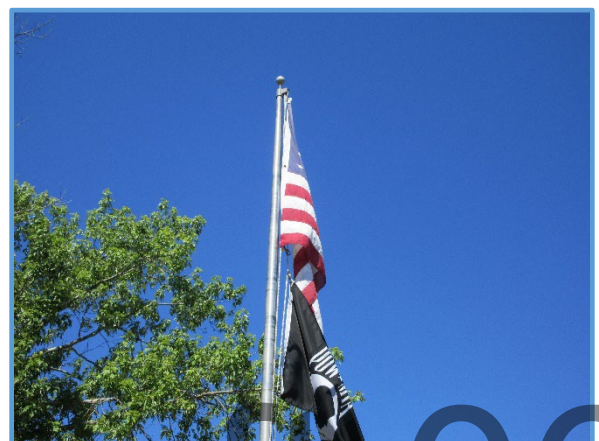
*Aluminum Flagpole*

An aluminum flagpole is located in the community and has a typical useful life of thirty (30) years. The flagpole was observed to be in average condition for its age, with finish loss, fading, and staining present.

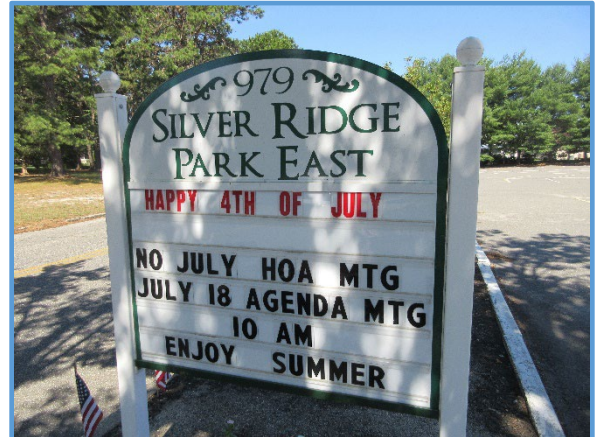
Sign

A Plexi-glass sign is located in the community and is affixed to two (2) wood posts. The sign has a typical useful life of twenty (20) years and was observed to be in above-average condition.

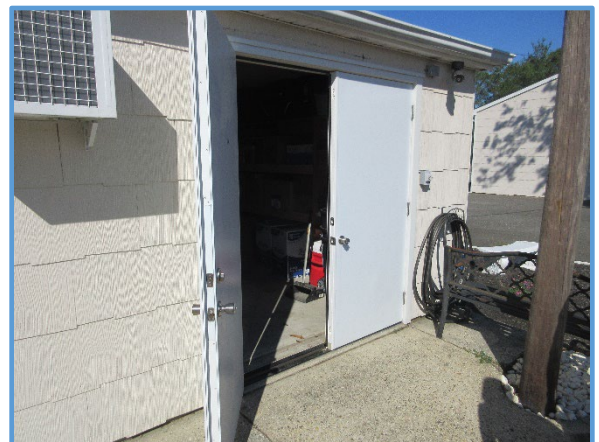
Garage Metal Door

The garage has both metal doors and a garage door. The components both have a typical useful life of twenty-five (25) years and were observed to be in above-average condition.

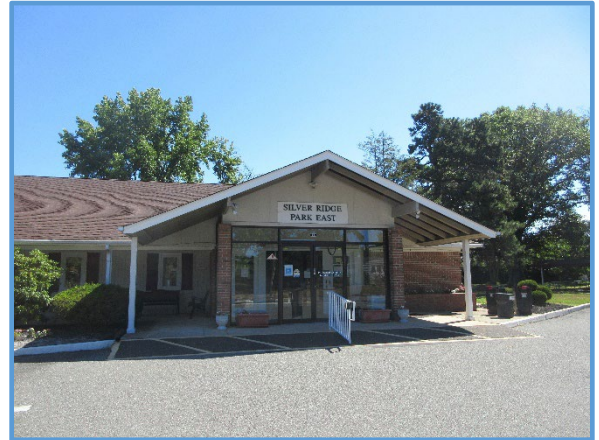
*Clubhouse Exterior*

The Clubhouse is weatherproofed with architectural roofing shingles, which have a typical useful life of thirty (30) years. The roofing was observed to be in average condition with minor staining and granular loss present.

The exterior elevation of the clubhouse is clad with asbestos shingles. FWH recommends that when the shingles are replaced, they are replaced with vinyl siding, which has a forty-five (45) year typical useful life. The asbestos siding was observed to be in below-average condition.

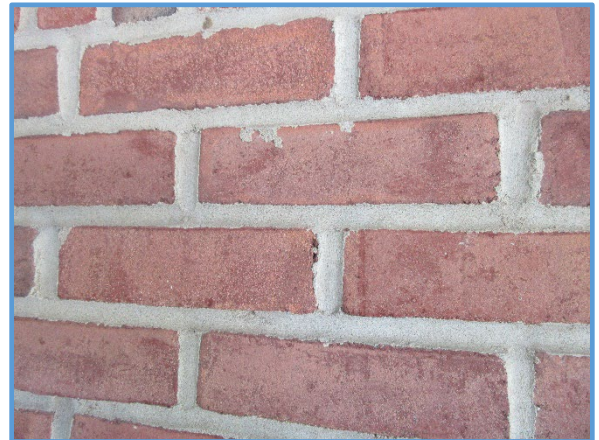
*Stone Veneer*

The brick veneer cladding the exterior elevations of the building will require repointing. Repointing is the process of removing the deteriorating mortar from the joints of the brick veneer masonry wall, and then subsequently replacing the removed or missing sections with new mortar. The brick facade was observed to be in average condition, possessing signs of minor spalling. Any cracks and displaced stone should be repaired to maintain a watertight envelope.

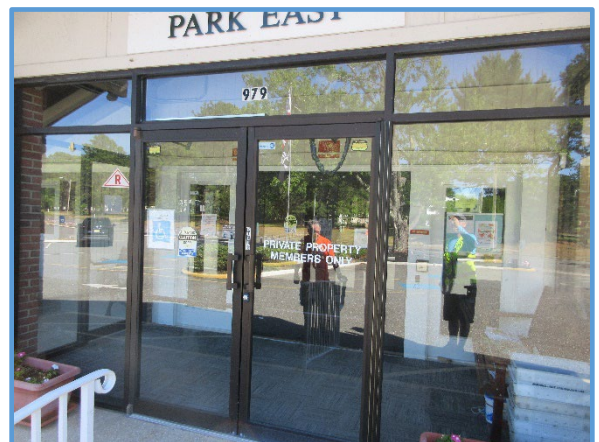
*Entrance Door*

The clubhouse has multiple styles of exterior doors including both single metal and wood doors, and a Dutch coat room door. The doors all have a typical useful life of twenty-five (25) years and were observed to be in average to above-average condition.

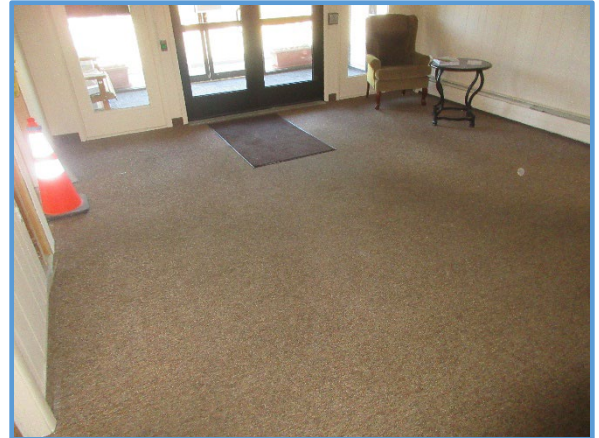
Carpet

Terrazzo flooring exists within the clubhouse and was observed to be in average condition with minor fading present. Hardwood flooring also exists in the building and was observed to be in average condition for its age with scuffs and scratches present. The carpet within the building has an eight to eleven (8-11) year typical useful life depending on how well it's maintained and how much foot traffic it endures. The carpet was observed to be in average to below-average condition.

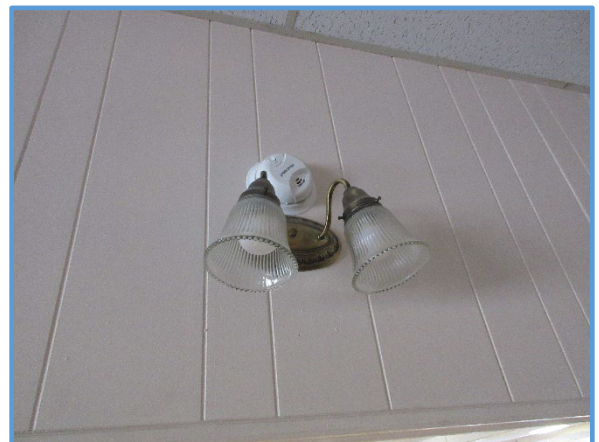
Light Fixture

The interior of the clubhouse is illuminated by fluorescent light fixtures, wall-mounted light fixtures, and exit signs. The lighting has a typical useful life of twenty-five (25) years and was observed to be in average condition with fading present.

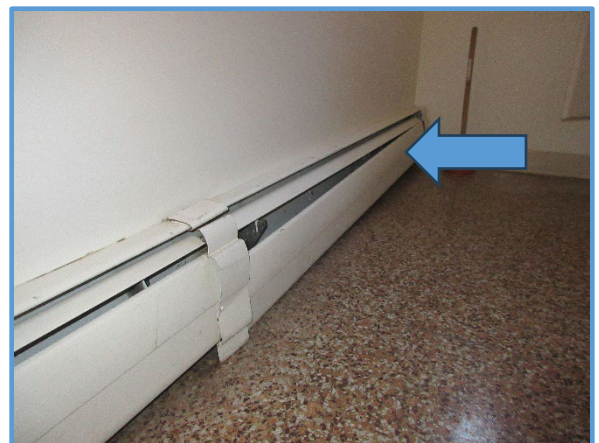
Baseboard Heater

The clubhouse is serviced by various mechanical equipment. The equipment includes, baseboard heaters, water pumps, air conditioning condensers, exhaust fans, and boilers. The baseboard heaters, air conditioning condensers, and water pumps have a typical useful life of twenty (20) years, while the exhaust fans possess a typical useful life of twenty-five (25) years and the boilers have a typical useful life of thirty (30) years. No mechanical, electrical or pneumatic testing was performed as part of our analysis. During the study preparation, FWH was not made aware of any functional or operational difficulties with the system.
